GENERAL CONDITION INSURANCE SURVEY AND ATTACHED LETTER OF OPINION OF VALUE

For Brooms Motor Yacht

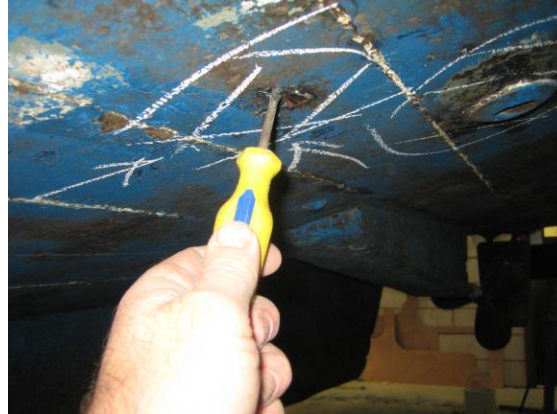
The hull construction below the waterline was carvel planked horizontally in what appeared to be Iroko hardwood over a mixture of sawn frames and steamed oak timbers and fastened with a mixture of screws and copper nails. The hull surface remained fair when viewed from a distance with no significant hogging or sagging identified. The hull surface was lightly impact tested with a small hammer at close intervals below the waterline and occasionally spike tested. Generally the majority of the underbody planking was showing no evidence of any significant planking damage or timber deterioration and the majority of the caulked and payed plank seams remained tight.

However, there were a number of areas of timber deterioration found and listed as follows.

1. Number 6 plank (P) (numbered from keel) was showing signs of significant timber deterioration 4 meters from the transom. Remove degraded timber by cutting back to sound wood, or renew plank to existing butt joints.

2. Number 3 plank (P) (numbered from keel) has commenced to soften 2500mm from stem. Cut back to sound wood and fit a Lloyds preferred glued and screwed fastened graving piece or if necessary remove plank to existing butt joints.

3. Number 5 plank (S) (numbered from keel) has commenced to soften 5 meters from the stem. If found necessary, renew plank to existing butt joint.
4. Number 10 plank (S) (numbered from keel) has commenced to soften 5 meters from the stem. If found necessary, renew plank to existing butt joint or treat locally with a glued graving piece.

5. Renew plank seams where necessary, dry out carefully, re-caulk and re-stop seams. (re-caulk open seam at waterline level port side aft transom position).

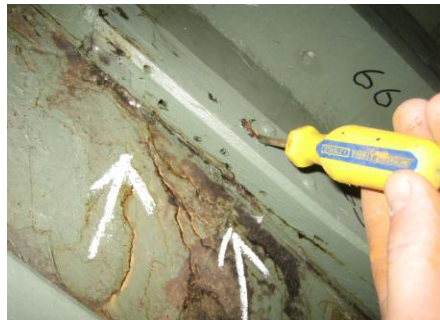
All frames were visibly inspected and tested by sounding and/or pricking of doubtful parts. The following frames were found defective. (see image above).

1. Steering gear. Number 65 frame (S) soft at heel.
2. Stern gland. Number 48 frame (P) soft centre and heel. Remove defective frames and fit new.

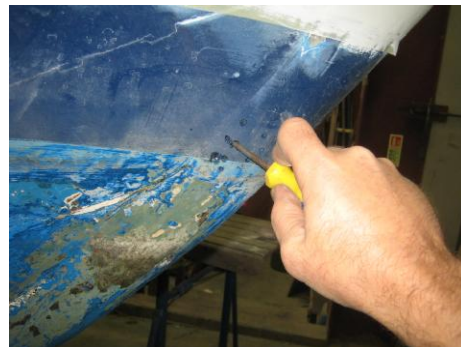
A straight stem with internal apron support and deadwood section below was considered fair and sound. However the stem at waterline level has previously been repaired with an epoxide type filler which has detached and the adjoining areas of timber were showing signs of significant timber deterioration, and this should not be overlooked.

1. Remove filler, cut back to sound wood, fit glued / scarfed graving piece using compatible timber. (see image over).

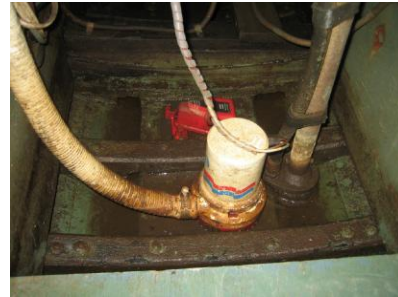
The engine bay hatches and traps located on the floor of the fore and aft berths allow access to the bilge. Various other traps were accessible through out. The bilges were considered clean and dry. Note: There was no ready access below areas of flooring, and I have not inspected woodwork or other parts of the structure which were covered, unexposed and inaccessible and am, therefore, unable to report that any such part of that structure is free from defect.

Two electrically operated bilge pumps with an estimated pumping capacity of 2,000 gallons an hour were secured in the lower bilge areas. The pumps had been competently installed and although not tested appeared effective. Although it was not possible to survey all the associated pipework in detail such as I was able to inspect generally appeared satisfactory with the connections and worm drives clamps in a serviceable condition.

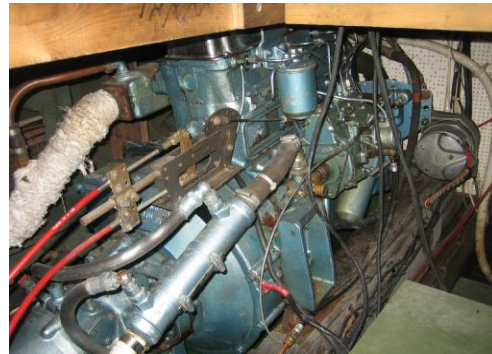
A visual inspection of the engines, filters and related connections showed no signs of abuse and a good maintenance regime became apparent. The stringers that support the engine mounts were timber and in turn they were secured to the hull and appeared to be free of stress. The flexible engine mountings were secure and in a good condition. The crankcase oils were checked and appeared to be clean and at the correct levels.

It was not possible to run nor check the compression of the engines nor was it practicable to remove injectors and check the actual cylinder pressures, however the machinery was superficially clean, free of significant rust and excessive oil leaks and appeared to be in a good/serviceable condition.

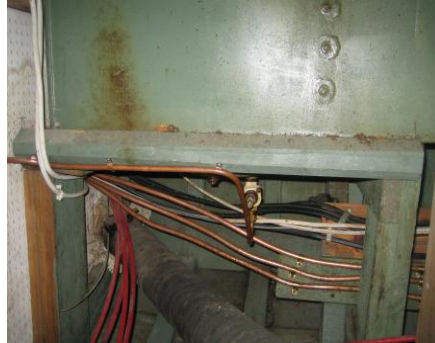
The vessel was fitted with two free standing fuel oil tanks of welded steel construction which were examined as far as practical and appeared externally in a good condition. It was not possible to open up the tanks and inspect their interiors. The material of construction was considered suitable for the fuel contained therein and appeared to comply with the 30 minute fire resistant requirement of BS 476/20. The tanks appeared to be properly secured and no sign of movement was observed.

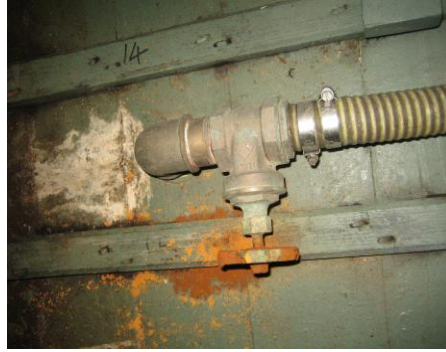
The valves and skin fittings were not drawn or opened for inspection but was examined in situ externally by hammer and scrape testing. The fitting was in a serviceable condition, and satisfactory operational with no obvious signs of water ingress in way of seals or glands, and although it was not possible to survey all the associated pipework in detail such as I was able to inspect appeared satisfactory with the connections and worm drives clamps in a serviceable condition. The topsides and transom were fitted with a number of ferrous and plastic skin fittings, all of which appeared to be sound where examined externally and were considered to be a reasonable height above the water line.

1. Strip, clean and service all sea cocks below the waterline annually.

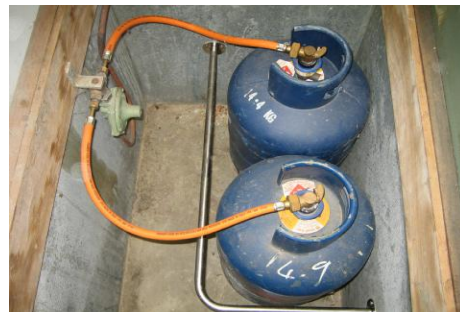
A four burner grill and oven was properly secured in the galley. All LPG appliance burners were lit and operated at their maximum setting at the same time and a satisfactory flame picture was present at each LPG appliance burner.

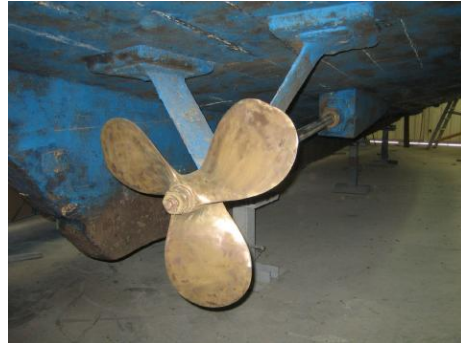
The stern gear was examined externally-without opening up-and was found in a good condition overall. The propellers were examined and hammer tested and found to ring true, and there was no sign of significant corrosion or dezincification in the metals. The propeller blades were individually sighted for obvious signs of significant deformation and none were found. It was not possible to check the condition of the keys and keyways, although the retaining nuts were satisfactory locked.

The stern tube and Y brackets were examined and were hammer tested and found to ring true and also scrape tested and there was no sign of significant corrosion or dezincification in the metals.
