UNDERBODY EVALUATION SURVEY FINDINGS

Type: Freeman 24 Sport.

Date of Survey: 14/6/ 2007.

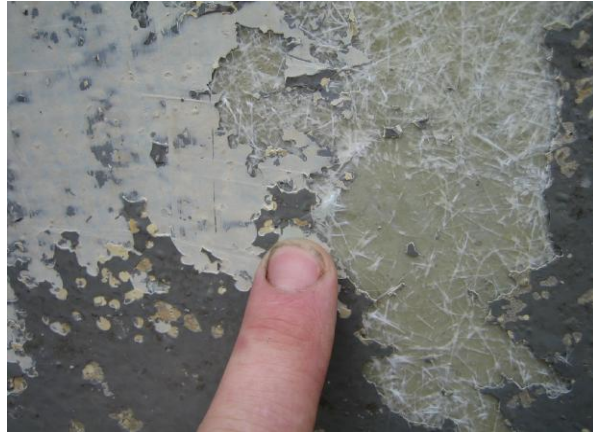
On first close inspection of the hull structure below the waterline, it became immediately apparent that a tool, commonly known as a Peeler had been used to remove the gelcoat and some of the underlying laminate. (similar to an electric planer. It is a hand held tool that can take off a measured thickness.)

It appears that this peeling process had been carried out previously during remedial works for hydrolysis / osmosis / blistering treatment and rectification. For seasons unknown by this Surveyor, the relaminating process with new material had not been carried out or completed. Thus leaving the hull structures prone to accelerated water ingress.

There was an apparent thin layer of epoxy type paint (see image above) which had been applied to the exposed laminates and fibres, but this was insufficient in thickness, and the majority of the coating system seen had been unprofessionally applied, and was poorly adhered with large sections missing.

Relaminating: Assuming the 'already completed' laminate removal has taken off all the hydrolysed laminate, the hull should now be ready for relaminating. It is obviously important that the vessel stays out of the water from this point forwards. Where it has not been practical to remove all the hydrolysed laminate, that which has been left will need to dry out. This can vary considerably, weeks, months, but assuming the worst of it has been removed, in practice, the drying time of the remainder is usually fairly short. The resin used in relaminating can be epoxy, polyester or vinylester resin.

Following the removal of any further hydrolysed material, drying and replacement of glass as necessary, a barrier coat should be applied.

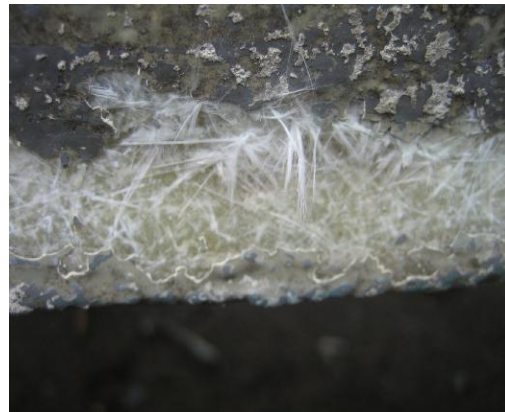
On carefully scrapping small areas of the hull sections, the presence of resin free, fluffy, glass fibre strands was also evident. (see adjacent photo image). There was however no indication of any sediment piles. (These typically indicate active hydrolysis, even though there was no visible blisters.)
