HULL CONDITION SURVEY & OPINION OF VALUE

For Broads Motor Cruiser

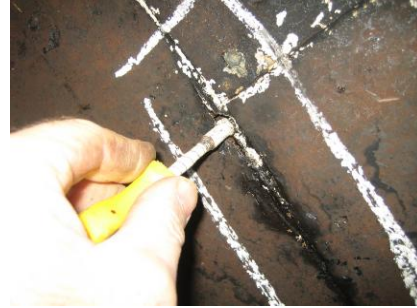
hogging or sagging identified. The hull surface was lightly impact tested with a small hammer at close intervals below the waterline and occasionally spike tested. Generally, 90% of the underbody planking showed no evidence of any significant planking damage or timber deterioration below the waterline externally and the majority of the caulked and payed plank seams remained tight. However, there were a number of areas of timber deterioration found requiring repairs and listed as follows.

1. Planks around the waterline forward and aft on both sides and chalk marked by the Surveyor, were showing signs of timber deterioration. Remove degraded timber by cutting back to sound wood, or renew planks to existing butt joints.
2. Various soft spots to planking found forward, amidships and aft and chalk marked by the Surveyor. Remove degraded timber by cutting back to sound wood, or renew plank to existing butt joints.
3. Renew plank seams where necessary, dry out carefully, re-caulk and re-stop seams where required.

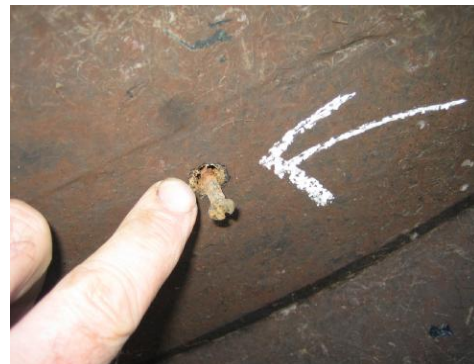
Two plank screw fastenings were removed for examination. There was signs of corrosion and dezincification to the metal screws seen. This is a serious omission and should not be overlooked. Steel fasteners, whether galvanized or not, are a very poor way to fasten a vessel if you want it to last a long time.

1. It appeared that large areas of new planking below the waterline had been fastened using mild steel screws. This is a very poor way to fasten a vessel. Employ a qualified Boat Builder to remove and inspect the plank fasteners, thus to provide a reasonable degree of certainty as to the planking soundness. Screws should be replaced with either bronze or stainless steel fasteners.

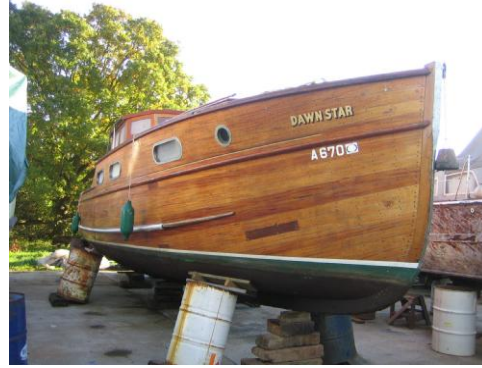
The topsides above the waterline were carvel planked parallel to the keelson in what appeared to be Mahogany hardwood timber over steamed bent frames and copper fastened.

The topsides remained fair when viewed from a distance with the varnish work adhering well to the timbers. The hull surface was lightly impact tested with a small hammer at close intervals above the waterline and occasionally spike tested. No evidence of any significant areas of planking decay or planking damage was found.

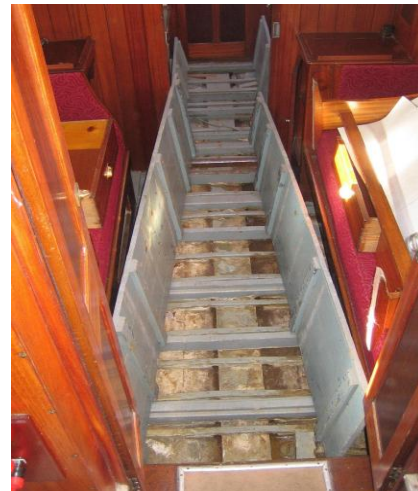
The frames and timbers above the waterline were typical of this type of construction and were securely fastened with copper boat nails and there was no evidence of any significant movement between the internal framework and the hull planking.

All frames, where accessible, were visibly inspected and tested by sounding and/or pricking of doubtful parts with no significant defects or significant degrading of the timbers observed.

1. New planking surfaces in the bilge areas were in need of routine paint maintenance in order to protect the timber.
