Insight Marine Surveys Ltd
10 Sydney Street
Ingham, Norwich, NR12 9TQ
Tel: 01692580119
Email: boat inspections@yahoo.com
Web: www.insightmarinesurveyors.co.uk

GENERAL CONDITION SURVEY REPORT

For Motor Yacht

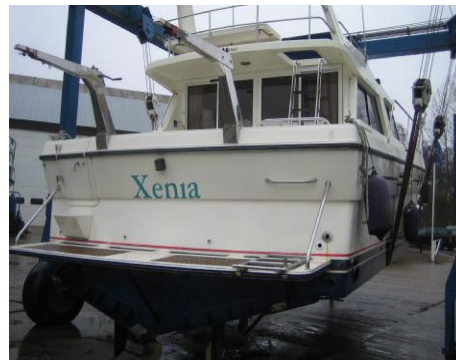
The side, bottom and transom panels were generally in good order, fair and free of obvious moulding and pigment defects but it was noted that there were a number of minor scratches and contact abrasions on the topsides. The stem and transom quarters were particularly examined and no significant contact gouges or abrasions noted. There was some ultra-violet light deterioration of the topside gelcoat surface but this to be of no structural

consequence. The bottom and side panels of the hull were lightly hammer tested using an engineers ball hammer to test to see if there were any obvious voids in the lay up but none were discovered. This was particularly carried out at acute points of the hull form or at points of contra flexure where such voids may be expected. No guarantee can be given, however, that such voids do not exist. The hull was sounded all over by this means with no indications of soft spots being noted in the gelcoat and, judging by the general hard resonance, the structure appeared to have been solidly built to a good standard. The hull was especially examined at the points where the bulkheads were fitted and no sign of a hard spot in these areas were noted nor were there any signs of gel coat cracking indicating that the shell was 'hinging' seen.

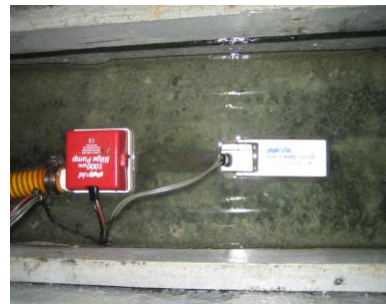
The vessel was subdivided by non watertight screen bulkheads. Oil and water separation was provided for. The engine bay hatches and traps located on the floor in the companionway allowed access to the bilge. Various other traps were accessible through out. Apart from the small amounts of standing water on either side bilge in the lazarette, the bilge areas were relatively clean and dry.

One electric bilge pump was visibly inspected between the engines. All parts of the systems, which were accessible without removal of bulkheads, panels, etc; were carefully examined. Every effort was made to determine the systems installation compliance compared to similar existing systems. The system had been sensibly installed and was found to be in a good operating condition.

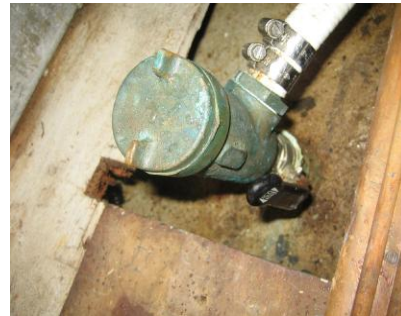
The skin fittings were not drawn or opened for inspection but were examined in situ externally by hammer and scrape testing. The fittings were of the gunmetal ball valve type with bronze skin fittings, and the valves appeared to be in a serviceable condition, satisfactorily operational, with no obvious signs of water ingress in way of seals or glands. Although it was not possible to survey all the other associated pipework in detail such as I was able to inspect appeared satisfactory with the connections and worm drives clamps in a serviceable condition.

The topsides and transom were fitted with a number of non-ferrous and plastic skin fittings, all of which appeared to be sound where examined externally and were considered to be a reasonable height above the water line.

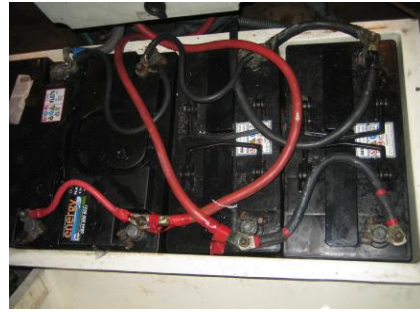
The DC system was fitted with a marine type breaker panel correctly installed. The breakers, wiring and associated equipment where accessible were found in good order and generally operational, with none of the wiring found to run in the bilge area and clear of any source of direct heat or fuel or gas piping. The wiring was PVC insulated, and in the limited places for inspection, the wiring was adequately clipped up and fitted where necessary with bulkhead glands and crimped end fittings and found in good order. The cable sizes all appeared to be adequate for the circuits examined and the DC cables were all of the multi-strand type.

The navigational lights were tested, and appeared to comply with the appropriate regulations, however the starboard light was not powering, and the bulb may require replacement.

2. Rectify the following circuit faults on equipment not operating. Starboard navigational light. Auto helm. Diesel warm air heater.
3. Although the engines appeared to be in a good / serviceable condition, carry out a thorough test of the engines prior to voyaging. Alternatively have a competent marine engineer inspect the engines/gearboxes/ genset and arrange an analysis of the oils.

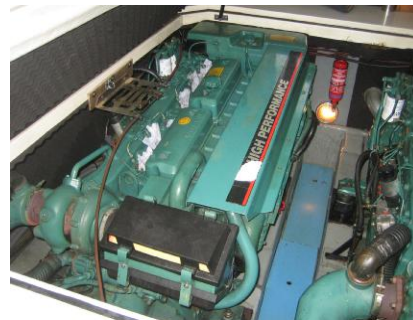
A visual inspection of the engines, filters and related connections showed no signs of abuse and a good maintenance regime became apparent. The stringers that support the engine mounts were cored fibre glass and in turn they were secured to the hull and appeared to be free of stress. The main flexible engine mountings were secure and in a good condition. The crankcase oils and gearbox oils were checked and appeared to be clean and at the correct levels. The water cooling caps were lifted and no signs of oil emulsification was noted inside.

It was not possible to check the compression of the engines nor was it practicable to remove injectors and check the actual cylinder pressures, however the machinery was superficially clean, free of significant rust and excessive oil leaks and appeared to be in a serviceable condition, however, it is always strongly recommended that the engines are further examined and tested by a

1. Although the engines appeared to be in a good / serviceable condition, carry out a thorough test of the engines prior to voyaging. Alternatively have a competent marine engineer inspect the engines/gearboxes and arrange an analysis of the oils.

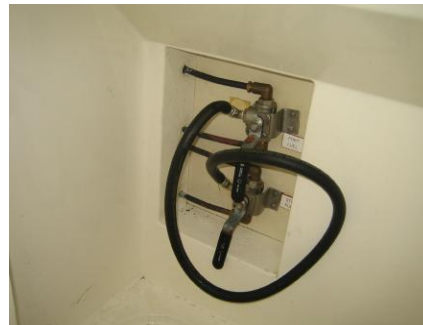
The vessel was fitted with two free standing fuel oil tanks of welded steel construction which were examined as far as practical and appeared externally in a fair condition. It was not possible to open up the tanks and inspect their interiors. The material of construction was considered suitable for the fuel contained therein and appeared to comply with the 30 minute fire resistant requirement of BS 476/20. The tanks were properly secured and no sign of movement was observed. There was some light corrosion visible to the accessible parts of the tanks, although this was not considered to be of any structural consequence.

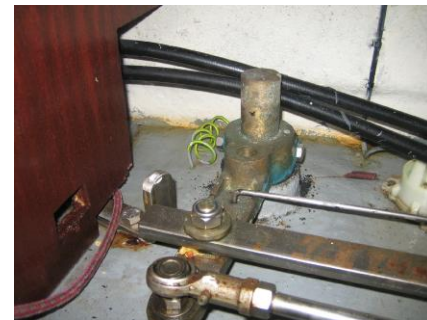
Bronze tiller levers were fitted to the rudder posts and linked to the steering positions by a hydraulic purging steering system. The rudders were found in a good condition with no significant play noted in the bearings at the 'thru' hull positions. The rudders could be rotated from stopper to stopper and were tried hard over and found to be in a good smooth operation from both helms. All parts of the system, which were accessible without removal of bulkheads, panels, etc; were carefully examined. Every effort was made to determine the systems installation compliance compared to similar existing systems. The system has been sensibly installed and was found to be in a good operating condition.

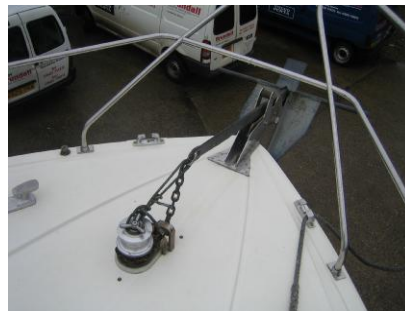
The main anchor was found in its dedicated position over the stem head fitting, with approximately 15 Fathoms of 32 x 25 x 6mm galvanised plain link chain cable, the length of which was not measured. A statistically significant number of links were measured for wear. It should be noted that the Classification Societies will allow up to 11% wear down in the links ends before requiring renewal of the chain. **NB.** Some links were showing corrosion and pitting and these should be further checked and tested within the next six months. The inboard end of the chain on the main anchor appeared to be securely attached to the vessel, although this is not guaranteed. The size of the anchor complied with the recommendations of the RYA Yacht Safety Document number C8/02.

The vessel was fitted with an electric windlass. The arrangements were such that it could be considered to be a strong point in accordance with the EU Recreational Craft Directive. It was considered to be capable of adequately accepting mooring, anchoring or towing loads. The winch was switch tested and proved powering from the lower helm position.

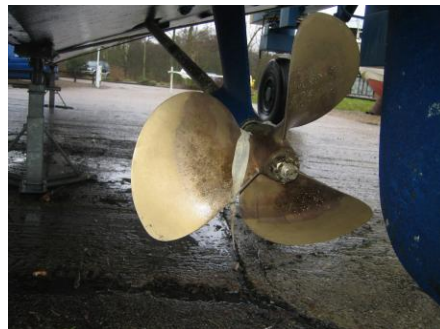
The propellers dimensions were not checked for matching with the machinery power and revolution output, however the propellers showed no sign of significant corrosion and the propeller blades were individually sighted for obvious signs of significant deformation and none were found.

It was not possible to check the condition of the keys and keyways, however the propellers were a snug fit to their shafts and properly secured by bronze locking nuts and steel split pins. When the shafts were rotated by hand they were free.

NB: The stern glands, which were of the bolted gland type, were examined - without opening up - and found in a serviceable condition. There was no sign of excessive leakage but it was not known when they were last opened and repacked. As the remaining adjustment appeared to be well over halfway to the end it is suggested that the opening of the glands and an inspection of the packing would be prudent during the vessels next haul out. There was also signs of salt encrustation in way of the stern glands and their attachment bolts.

1. The stern glands, which were of the bolted gland type, were examined - without opening up - and found in a serviceable condition. There was no sign of excessive leakage but it was not known when they were last opened and repacked. As the remaining adjustment appeared to be well over halfway to the end, it is suggested that the opening of the glands and an inspection of the packing would be prudent during the vessels next haul out. There was also signs of salt encrustation in way of the stern glands and their attachment bolts.

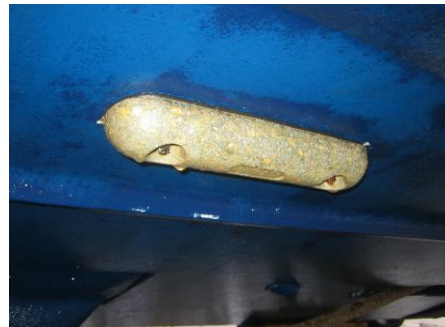
The vessel was fitted with two hull anodes, and two trim tab anodes. These were attached by way of steel bolting. The bolts were showing no signs of corrosion and the hull anodes were showing little wastage. (port hull anode replaced on day of inspection). The hull anodes were, inside the hull properly bonded to the engines stern gear seat, P brackets etc and to various overboard discharges by a clearly marked multi stranded earth wire of about 4mm square. The bondings were examined as far as practicable limitations of access allowed and were found good.

The anodes appeared to be of the Zinc type. If it is necessary at some time for the vessel to change from salt to fresh water, or visa versa then it should be borne in mind that this will have a deleterious effect on the anodes fitted. Magnesium or aluminium anodes (which are suitable for fresh water) have a much higher driving potential than anodes manufactured from zinc. If a vessel fitted with magnesium or aluminium anodes passes into salt water for anything longer than about seven days, the anodes will waist away very quickly. Vessels which are fitted with magnesium or aluminium anodes moving into a salt water environment for longer than a week should be, therefore, fitted with a replacement zinc anodic system. Conversely vessels fitted with zinc anodes(suitable for use in salt water) will find over a period exceeding about seven days that the metal will be coated with an impervious off-white crust of zinc salt which will very effectively prevent it working even when returned to salt water. After any trip into a fresh water environment a vessel fitted with zinc anodes should have these thoroughly scaled back to bright metal. If proceeding into fresh water for longer than about seven days a vessel should be fitted with replacement magnesium or aluminium anodes.
