GENERAL CONDITION SURVEY FINDINGS

Type: Pleasure Yacht.

Model Year: Broom 41.

Builder/designer: Brooms & Sons of Brundall, Norfolk, England.

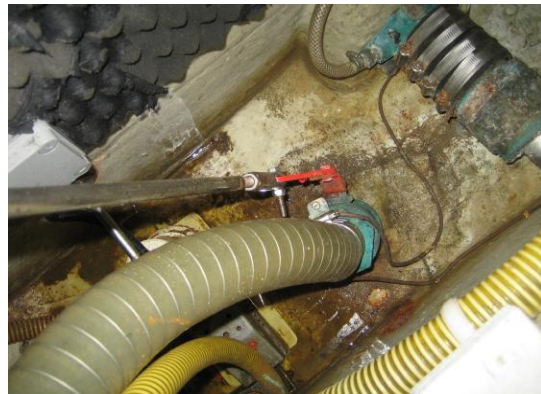
The skin fittings were not drawn or opened for inspection but were examined in situ externally by hammer and scrape testing. The fittings were of the gun metal ball valve type with bronze skin fittings and appeared to be in a serviceable condition, with no obvious signs of water ingress in way of seals or glands, however some corrosion and salt crustation was noted around the engines seacocks and they appeared to be seized.

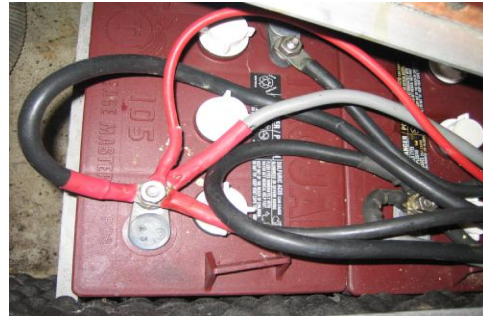
The batteries were installed aft of the engines and were properly secured and covered over. The battery terminals were clean and tidy and there was no evidence of over-filling. The batteries were considered adequately ventilated for the charging facilities installed onboard and the batteries appeared to be in reasonably good condition

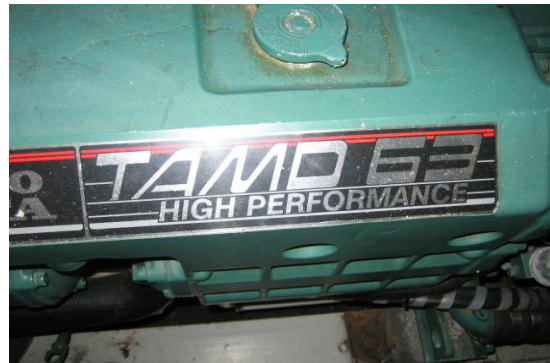
A visual inspection of the engines, filters and related connections showed no signs of abuse and a good maintenance regime became apparent. The stringers that support the engine mounts were steel and in turn they were secured to the hull and appeared to be free of stress. The main flexible engine mountings were secure and in a good condition. The crankcase and gearbox oils were checked and appeared to be clean and at the correct levels. The water cooling caps were lifted and no signs of oil emulsification was noted inside.

During the test run a simple audio test was carried out, no undue knocks were noted in the bearings or running gear and no undue noise, piston slap, or bearing failure was noted and such simple running tests as we were able to effect indicated that the machinery appeared to be functioning correctly. It was not possible to check the compression of the engines nor was it practicable to remove injectors and check the actual cylinder pressures, however the machinery was superficially clean, free of significant rust and excessive oil leaks and appeared to be in a serviceable condition, however, it is always strongly recommended that the engines are further examined and tested by a competent Marine Engineer familiar with this type of machinery prior to purchase.

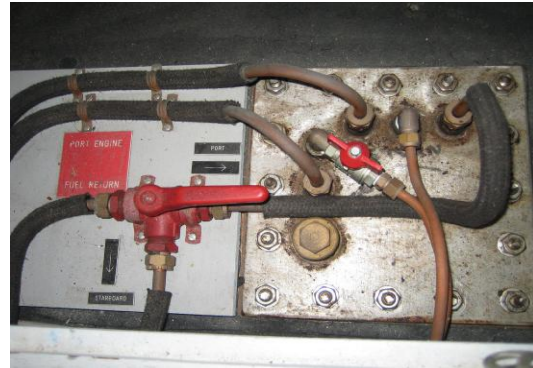
The vessel was fitted with two free standing fuel oil tanks of welded steel construction which were examined as far as practical (but not pressure tested) and found externally in a good condition. There was no corrosion visible to the accessible parts of the tanks. The tanks were not filled up and it was not possible to check fully their oil tight integrity and this is not guaranteed. There was no obvious signs of leakage from the connections or fittings. The material of construction was considered suitable for the fuel contained therein and appeared to comply with the 30 minute fire resistant requirement of BS 476/20 and the tanks appeared to be properly secured and no sign of movement was observed.

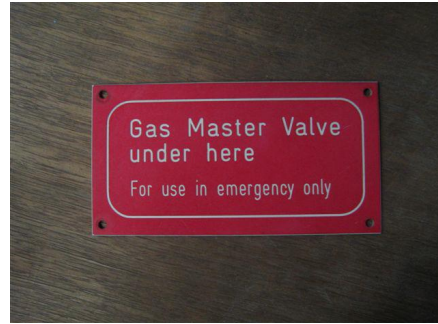
The copper supply tubing was visually inspected where accessible and appeared to be in a good condition and properly secured. The pipework appeared to be protected, to minimise the possibility of damage where it penetrated bulkheads.

The GRP, timber and soft furnishings nearby the source of heat were specially examined and no sign of heat damage, charring or scorching was noted.

1. Cylinders must be secured so that the possibility of cylinders damaging low-pressure regulators, pipework or other LPG system components is minimised.
2. The flexible neoprene gas cylinder connections were dated 1995, they are therefore beyond their recommended life of five years and should be replaced.
3. Clearly label the main and appliance gas shut off valve locations. (*example image shown above*).

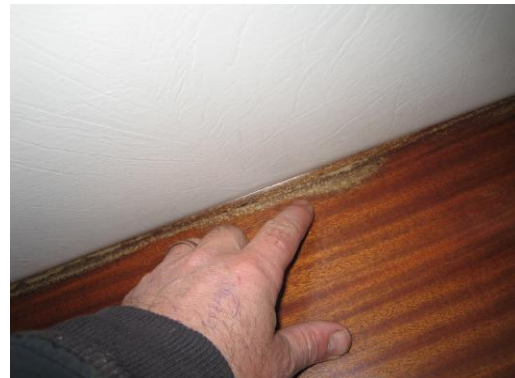
The windows and seals which were aluminium framed with safety glass, and were examined and found to be in a serviceable condition. It was not possible to water test these items and the drains will require cleaning through. A few areas of sealant were visible on the exterior, presumably an indication of an attempt to cure leakage.

Discoloration to internal woodworks in the main saloon were evident on the interior also. The windows and shuttles appeared to be strong enough to withstand the water pressures likely to be encountered within sea areas for which the vessel was apparently classified.

1. To stop windows leaking you have to use a non-hardening caulking so that the caulking can move with the expansion. To deal with this problem, you have to remove the frames, rebed them and refasten them less tightly than they were previously installed.

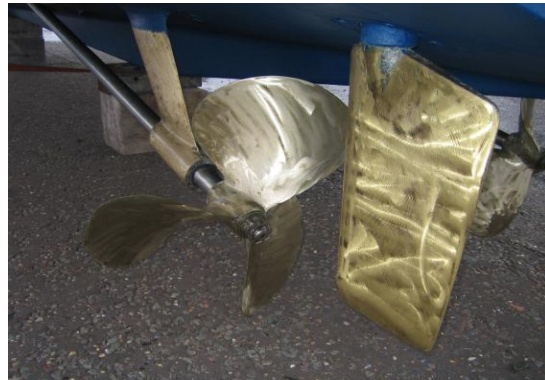
The stern gear was examined externally-without opening up-and was found in a good /serviceable condition. The propellers dimensions were not checked for matching with the machinery power and revolution output. The propellers showed no sign of corrosion and the propeller blades were individually sighted for obvious signs of deformation with no tip

damage noted. It was not possible to check the condition of the keys and keyways, however they were a snug fit to their shafts and properly secured by bronze locking nuts and steel split pins. When the shafts were rotated by hand they were free. The stern gland/stuffing boxes were secure and bolted tight.
