SURVEY REPORT AND ATTACHED LETTER OF OPINION OF VALUE

Vessels particulars

Name of vessel:
Hail Port: Granton. British Flag.
Owner:
Hull ID Number: Official Number:
Intended use: Commercial activities.
Navigation Limits: Category A-Ocean. Merchant shipping regulations.
Date of valuation:
Last Hauled: January 2005.
Type: Steel Motor Yacht .
Builder/history: Fishing vessel, constructed by Hall Russell &Co. Converted by Putford Enterprises for use as a standby vessel and sold by them in September 1993 to the present owner who is presently converting her into a luxury Motor Yacht.
Year of Built: 1960 Circa
LOA: 32 Metres **Beam:** 7.35 Metres **Draft:** 3.36 Metres.
Gross Tons: 235 GRT.
Main Engine: Eight cylinder/ turbo/ 1000HP diesel engine driving shaft.
Max speed: 12 Knots.
Colours: White topsides and teak laid deck.
Weather: 45 degr.F,clear, breezy.
Fuel capacity: 30 Tons.
Water capacity: 6 Tons.
Waist holding tank capacity: Not observed.
Coding: For MCA Compliance-to be completed.

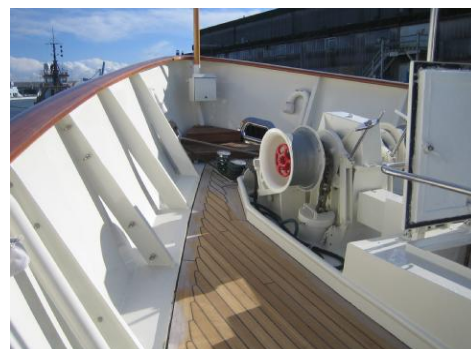
Superstructure / decking.

Teak forward and aft decks were fitted over fabricated steel. The gunwhales were rolled with sides plates with substantial hardwood capping. Visibly inspected and found to be in a good condition, satisfactory and effective. Where it was possible to examine the deck fastenings these were found adequate, in generally good order and the planking was properly secured. The deck and superstructure unit was particularly examined for cracks in highly stressed areas and around deck fittings but no defects were found. The deck was tested in a number of places, and no significant undue flexing of the deck structure was noted.

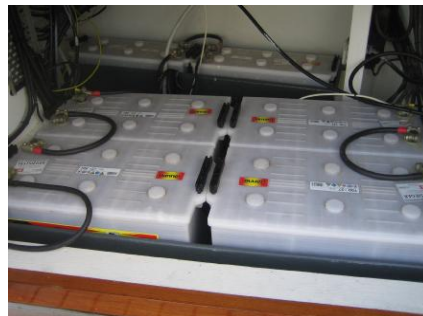
Electrical installation

Remedial works on various electrical AC/DC items were still in progress and this should not be overlooked.

The 3 phase/30Hz-380 or 420Volt system and two sets of ships batteries were visibly inspected where accessible, the heavy duty lead acid type batteries were adequately secured against any movement. I suggest the batteries pillar terminal covers are properly PVC covered. The area of installation was considered adequately ventilated and the batteries appeared to be in reasonably good condition.

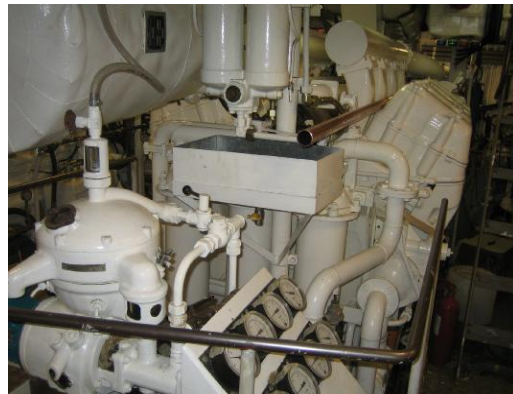
Engine installation

An English Electric 1000BHP 8 cylinder/turbo diesel engine was installed, serial number IH5236, coupled to a Michael Bearings hydraulic reverse/reduction gearbox. The engine was solidly mounted on substantial engine beds. The engine was inspected visually and appeared to be in serviceable condition, well secured with no evidence found of loose mountings or displaced shims.

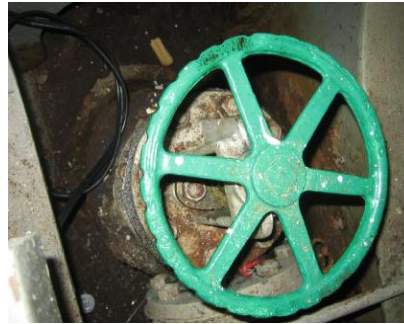
Sea valves and skin fittings

The fittings were not drawn or opened during this inspection, but various valves were examined in situ internally by hammer and scrape testing, and they were considered satisfactory operational with no obvious signs of water ingress in way of seals or glands. Although it was not possible to survey all the associated pipework in detail such as I was able to inspect appeared satisfactory with the connections found to be in a serviceable condition.

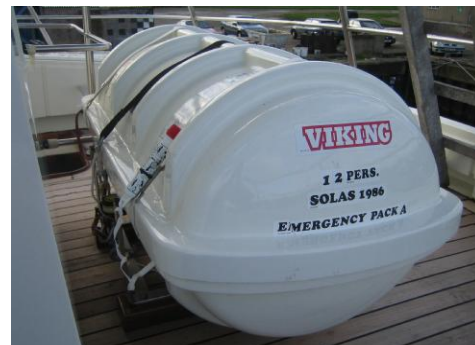
Fire fighting, Navigational & Safety equipment

The vessel carried adequate Fire fighting and Safety equipment presently under MCA installation supervision, and formed under the MCA guidelines. Personal safety equipment has not been inspected within the scope of this survey.

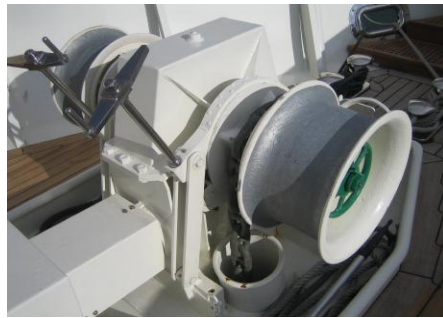
Ground tackle

Two suitable Danforth type anchors and a hydraulically operated winch and gypsy were secured onboard, and a dedicated anchor attachment point was fitted. The size of the anchors complied with coding recommendations and windlass arrangements were such that it could be considered to be a strong point in accordance with the necessary directives and it was considered to be capable of adequately accepting mooring, anchoring or towing loads. The winch was not tested during this inspection.
