GENERAL CONDITION INSURANCE SURVEY AND ATTACHED LETTER OF OPINION OF VALUE

For Brooms Motor Yacht

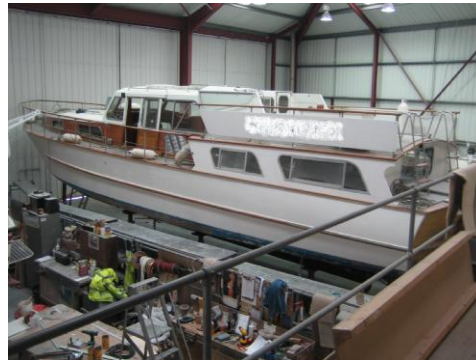
An unusual marc, with apparently only four constructed from this well known recognised builder., a timber constructed Motor Cruiser providing eight berths in three cabins, constructed to a design relevant to the late 1960's.

She is of hard chine bilge timber construction with a shallow tapering keel, flat transom, and curved stem. She is a product of the era of the tall sided majestic looking wooden Broadland Motor Cruisers designed specifically for inland water ways use, although quite cable of light inshore / coastal work.

There was evidence that the aft cabin had been materially and substantially modified to make the aft sections of the vessel beamier and therefore different from her production sister ships.

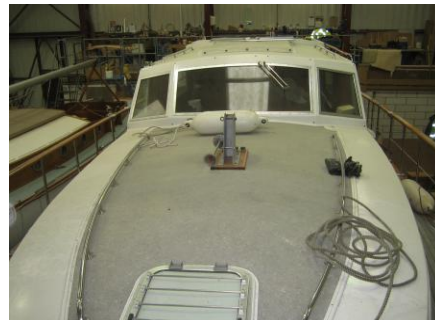
The deck was constructed from softwoods over substantial hardwood deck beams and beam shelves and sheathed covered and or teak planked. Visibly inspected the coverings were found to be in a good condition and free from any significant defects or deterioration. The deck was hammer tested with soundings sharp and no signs of degrading of the teak decking was found.

The coach roofs and sidings were of Mahogany construction, stained and varnished. These were closely inspected and no signs of significant timber deterioration was observed.

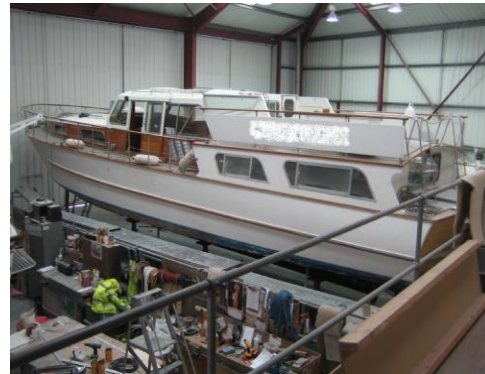
..... is a fine example of a classic Gentleman's Motor Cruiser, she has been well designed and extremely well constructed. Her interior layout has been well thought out and has many innovative ideas, which helps make use of all the available space.

Brooms & Sons, are well known for their boat building and fitting out work, and they undoubtedly had some good craftsmen in the 1960's. She has been well maintained by her previous owner, and has very few defects for a vessel of her age and type. She was found to be in a good structural condition overall.
