UNDERBODY EVALUATION SURVEY FINDINGS

Type: Freeman 24 Sport.

Date of Survey: 14/6/ 2007.

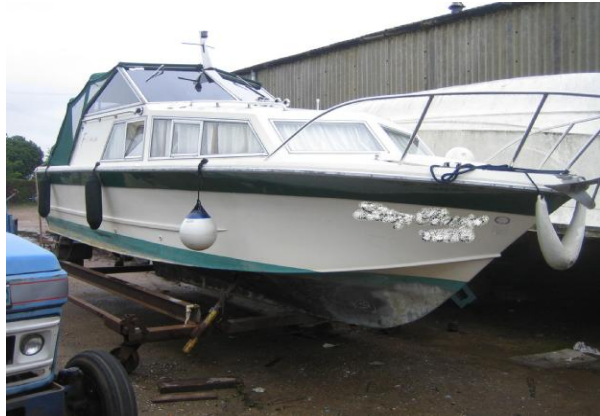
There was an apparent thin layer of epoxy type paint (see image above) which had been applied to the exposed laminates and fibres, but this was insufficient in thickness, and the majority of the coating system seen had been unprofessionally applied, and was poorly adhered with large sections missing.

Following the removal of any further hydrolysed material, drying and replacement of glass as necessary, a barrier coat should be applied.
