Insight Marine Surveys Ltd
10 Sydney Street
Ingham, Norwich, NR12 9TQ
Tel: 01692580119
Email: boat inspections@yahoo.com
Web: www.insightmarinesurveyors.co.uk

GENERAL CONDITION SURVEY REPORT

For Motor Yacht

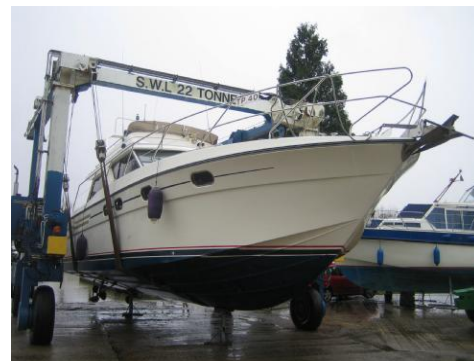
A precise specification for the structural lay up was not available at the time of the survey and this cannot be confirmed, however the hull construction appeared to be of typical solid polyester laminate with fibreglass matt and woven roving. The internal hull structure consisted of cored fibre glass floor stringers, partitions, plywood bulkheads and joinery bonded to the hull, and deck moulding.

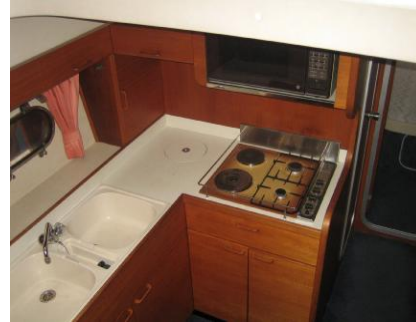
The interior was found to be in a good cosmetic condition, and provided six berths in three cabins. The saloon, and berths were fully lined and fitted out to a good standard.

Soft furnishings remain in a good condition. It is not known whether foam used in the soft furnishings was fire retardant.

Bulkheads and joiner work showed good care and maintenance. The furniture was constructed from hardwood framing. The floors were carpet covered and the majority of the drawers and locker doors appeared functional.
