GENERAL CONDITION SURVEY FINDINGS

Type: Pleasure Yacht.

Model Year: Broom 41.

Builder/designer: Brooms & Sons of Brundall, Norfolk, England.

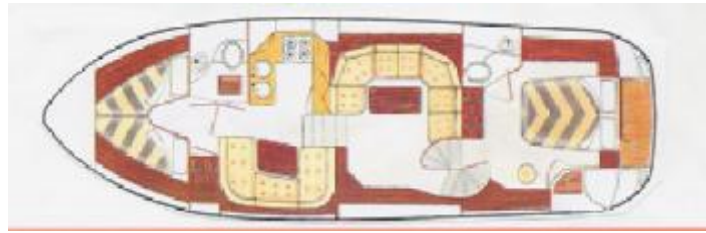
The interior was found to be in a good cosmetic condition, and provides six berths in three cabins. The saloon, and berths were fully lined and fitted out to a good standard. The upholstered sections were in a fair condition. Bulkheads and joiner work showed reasonable care and maintenance. The furniture was constructed from hardwood framing. The floors were carpet covered and the majority of the drawers and locker doors appeared functional.

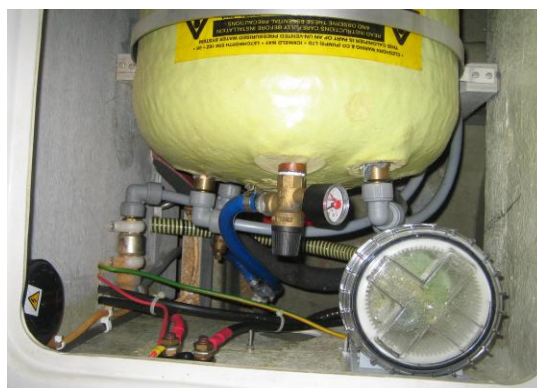
The vessel was fitted with a freshwater tank which was not accessible/inspected during this inspection. The tank was not filled up due to winterising and therefore it was not possible to check fully the systems watertight integrity and this is not guaranteed although no signs of leakage from the joints or fittings were noted.

The plumbing was of the plastic flexible piping and fitted with a pressure pump and was examined as far as practicable and found generally in good order with the worm drive clamps in a good condition. The hot water calorifer tank was found adequately secured (*two screws loose on one strap*) with the associated hot water hoses found in a good condition with no visible deterioration and linked to the exhaust side of the port engine.
